Manhole Inspection Summary

Manhole # S17A1_012MH

Insp Date: **12/30/08 5:00 PM**

Location Address: **2722 WASHINGTON BD**

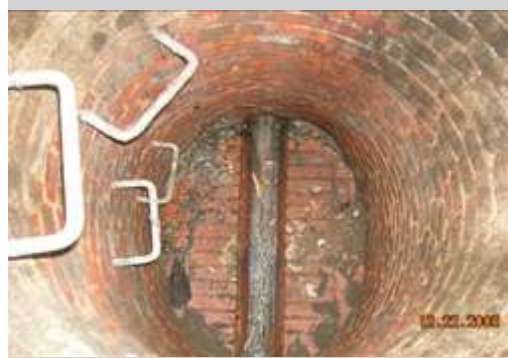
Top View

Type: **Sanitary** Condition: **Worn** Cover Material: **Cast Iron**

worn cover

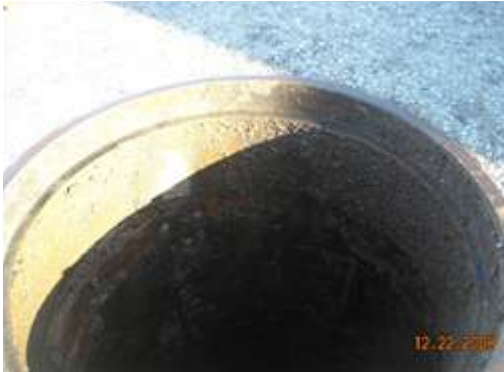
Defect

☐ Prev. Rehab Weather: **Dry** Subject To Ponding: **Sheeting**

Frame Offset: **0** (in.) Condition: ☐ Sound ☐ Cracked ☒ **Leaks**

INFLOW EVIDENCE FROM SHEETING

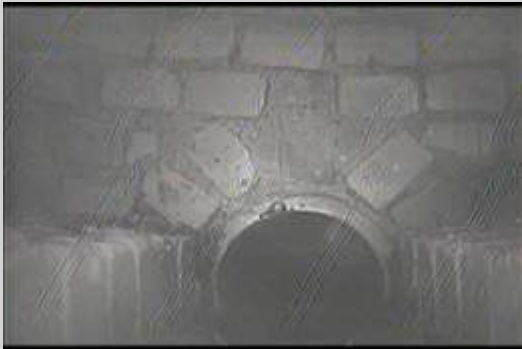
12 O'Clock Outflow

8 in. Circular Gravity Sewer
Pipe Out @ 12 O'Clock

Pipe Height: **8.4** (in.) Rod and Bar (Angled)
Pipe Material: **Clay** ☐ Pipe Lined
Invert Depth: **8.55** (ft.) Flow Characteristics: **Slow**
Deposits: ☒ None ☐ Mud ☐ Sludge ☐ Debris ☐ Grease
Silt Depth: **0** (in.) Deposits Extent:
Infiltration: **None** Pipe Seal Cond: **Sound**

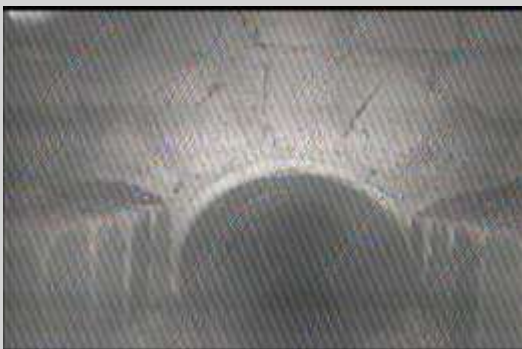
6 O'Clock Inflow

8 in. Circular Gravity Sewer
Pipe In @ 6 O'Clock

Pipe Height: **8.4** (in.) Rod and Bar (Angled)
Pipe Material: **Clay** ☐ Pipe Lined
Invert Depth: **8.13** (ft.) Flow Characteristics: **Slow**
Deposits: ☒ None ☐ Mud ☐ Sludge ☐ Debris ☐ Grease
Silt Depth: **0** (in.) Deposits Extent:
Infiltration: **None** Pipe Seal Cond: **Sound**
